Metchosin Firehall Building Assessment

issued: 2025-June-19

1.0 summary

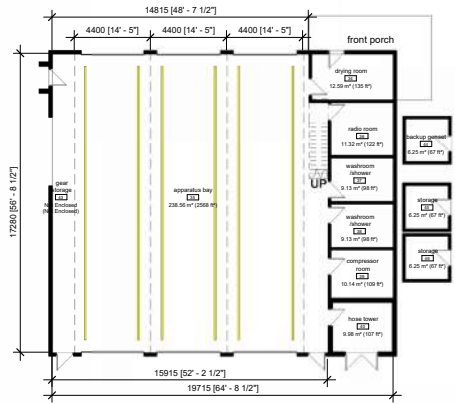
1 existing app bay
scale - 1 : 200

- Apparatus Bays – the existing firehall has 3 drive through tandem bays. The bays measure approximately 17.3m (56’-8”) long x 4.4m (14’ -5”) wide
 - The current bays themselves are too small to accommodate the current standard for emergency vehicle sizes. Width and length of the bays being the most crucial deficiency

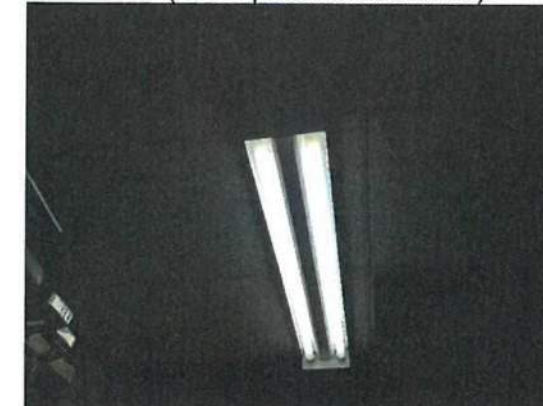
Fluorescent Light Ballast; Fluorescent Tube
Lights (PCB; Mercury)

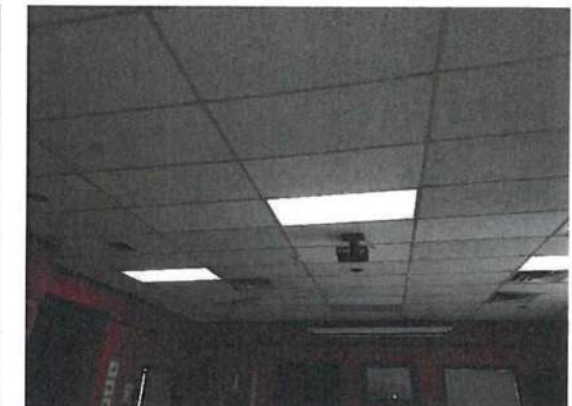
Fluorescent Light Ballast; Fluorescent Tube
Lights (PCB; Mercury)

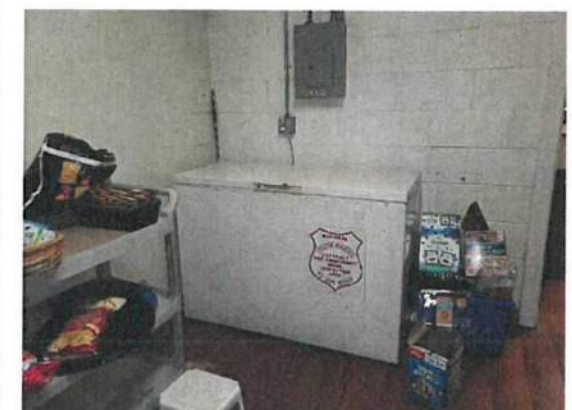
Freezer (ODS)

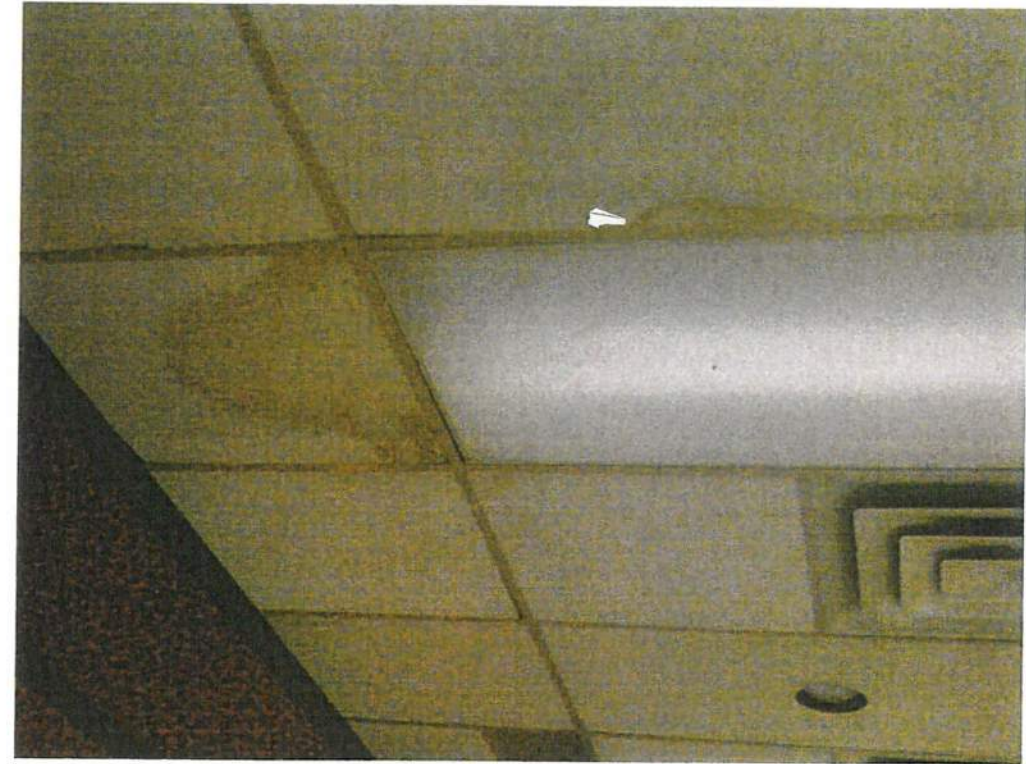
Above is a picture in the lounge by the back entrance, as our facility is not only occupied with volunteer firefighters, the scouts, the seniors, SAR and EOC personal and other local municipal and Westshore organizations. Many events such as Halloween, School Expo, Auto Ex Competitions and many forms of training, the public perception portrays a negative effect on our hall and community.

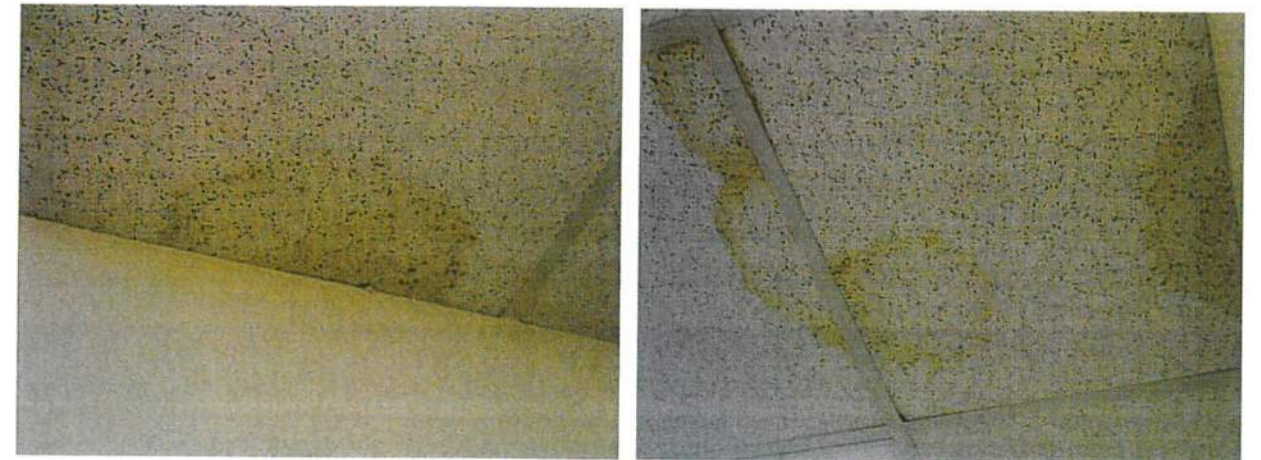
Interior hallway towards offices.

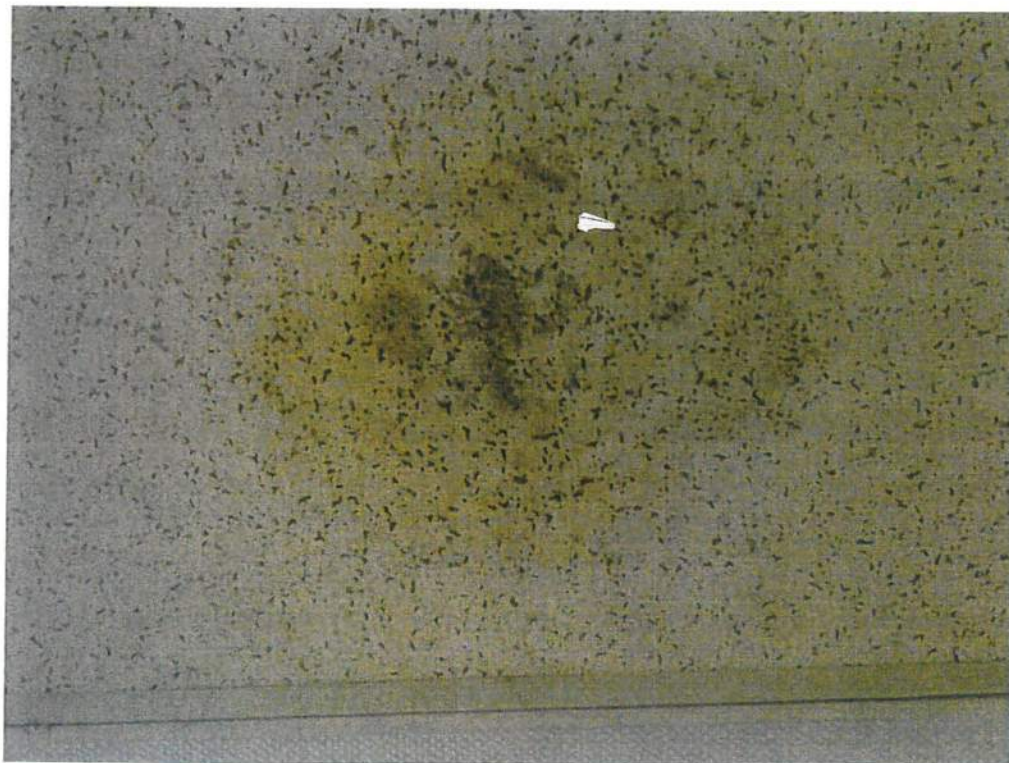
Roof interior inside the Fire Support personnel's office.

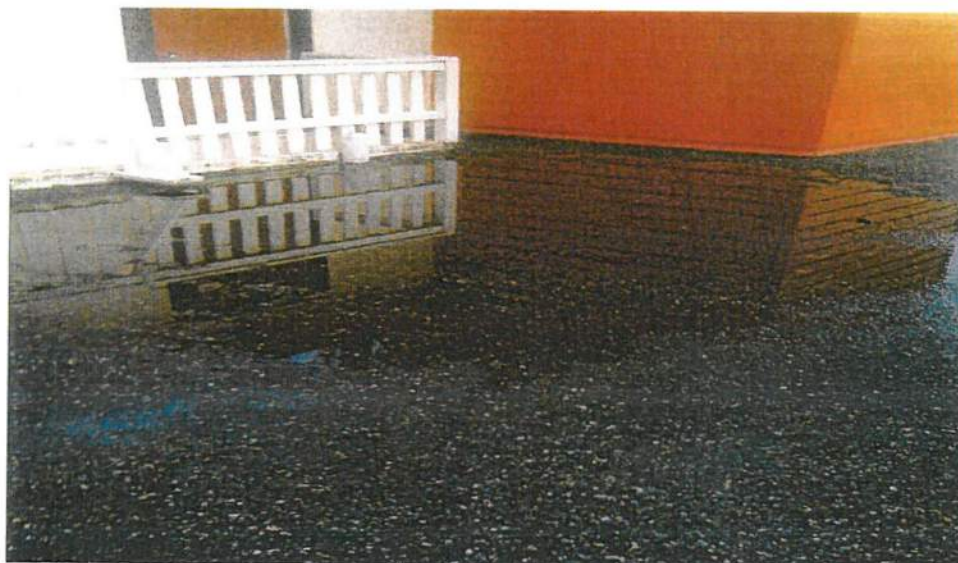
The pooling you see here is called "pondling", location here is outside the upper training room classroom. One of the issues here is the added weight of water on our structure, also improper location of drains.

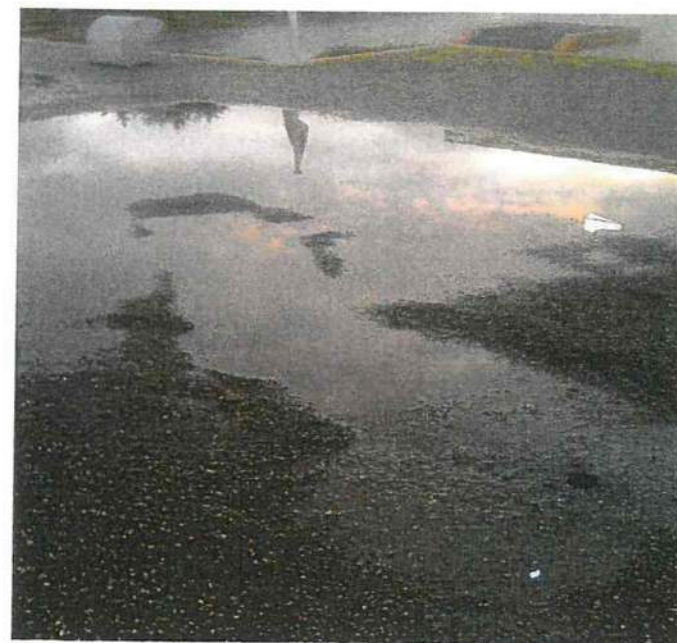
From the last photo, turning 90 degrees, facing flag pole, more pondling, added weight and improper drainage.

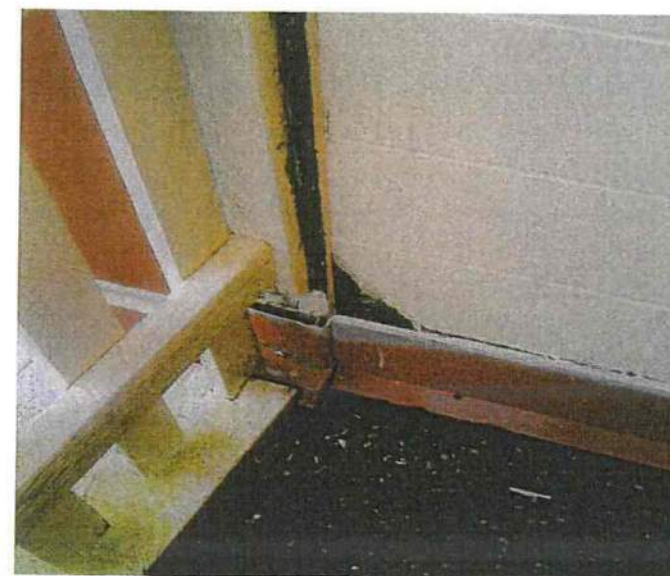
Location upper training room door, part of cinderblock is missing, and flashing not adhere to building.

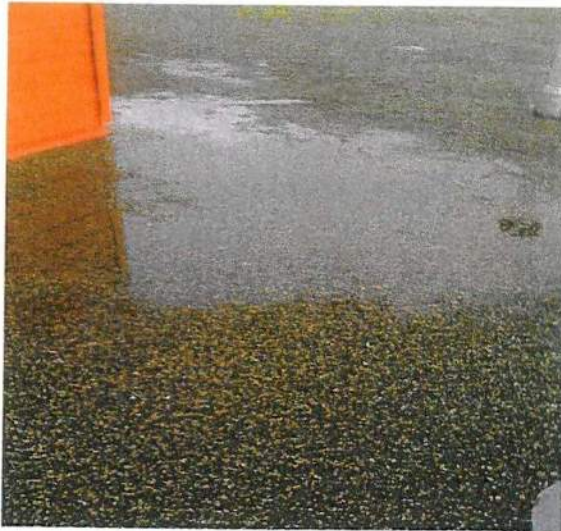
Roof adjoining old hose tower, more pondling, weight, pondling at seem of structure.

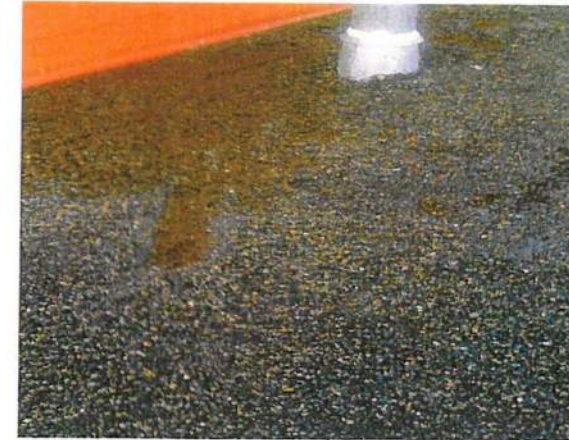
Pondling at old hose tower structure front side at roof.

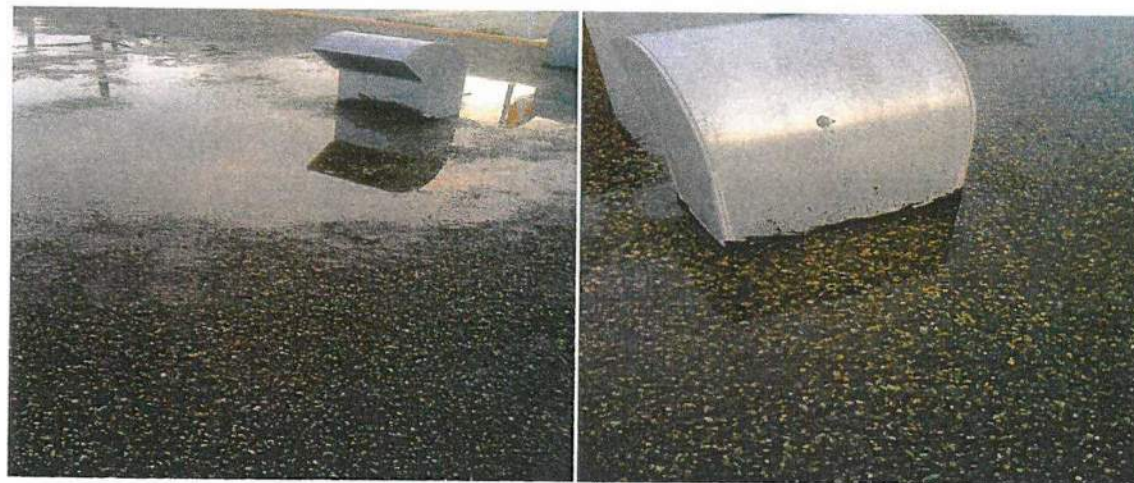
More pondling, the issue here the pondling is around HVAC outlets, which has possible egress to interior.

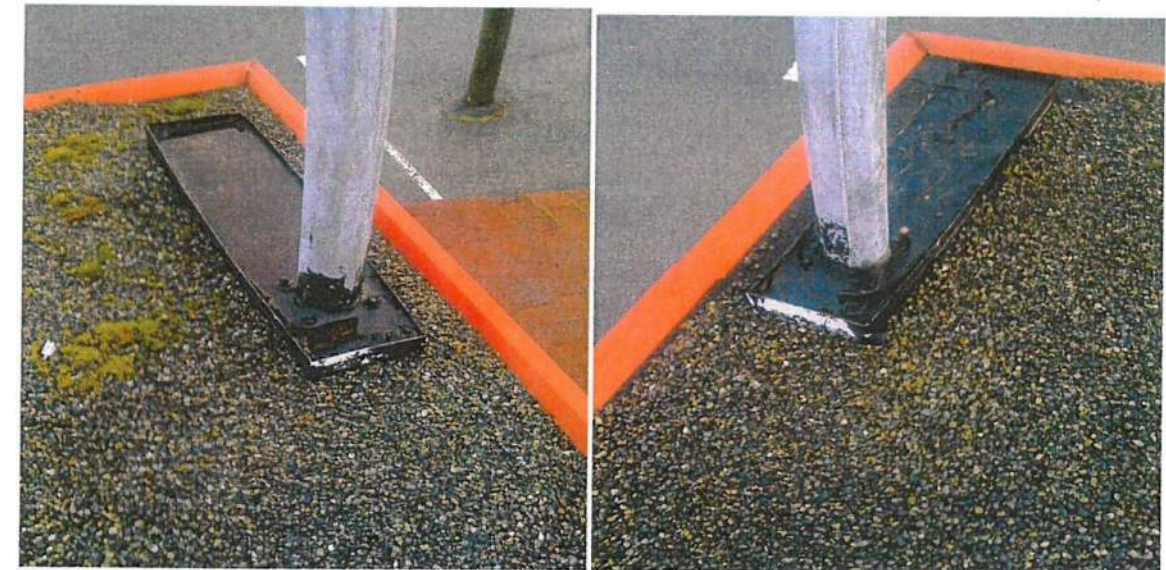
Light standards mounted front of hall on roof, improper installion, pan had been inadequately filled with tar, thus pans are filled with water. Should be filled and with concave topping to allow water to run off.

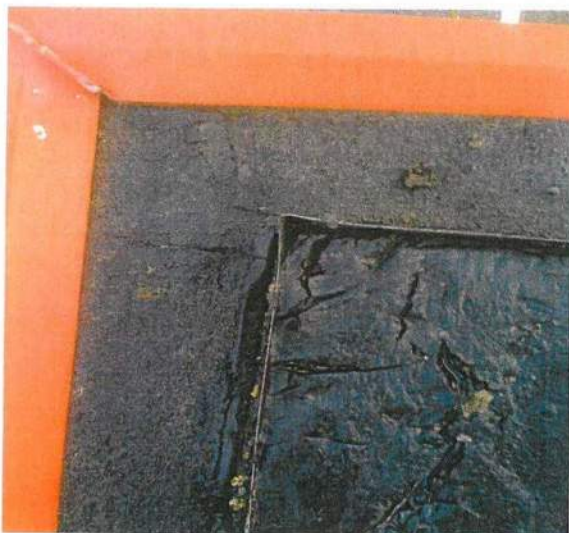
Exposed tar, no gravel to protect, cracks which make good egress of water to interior.

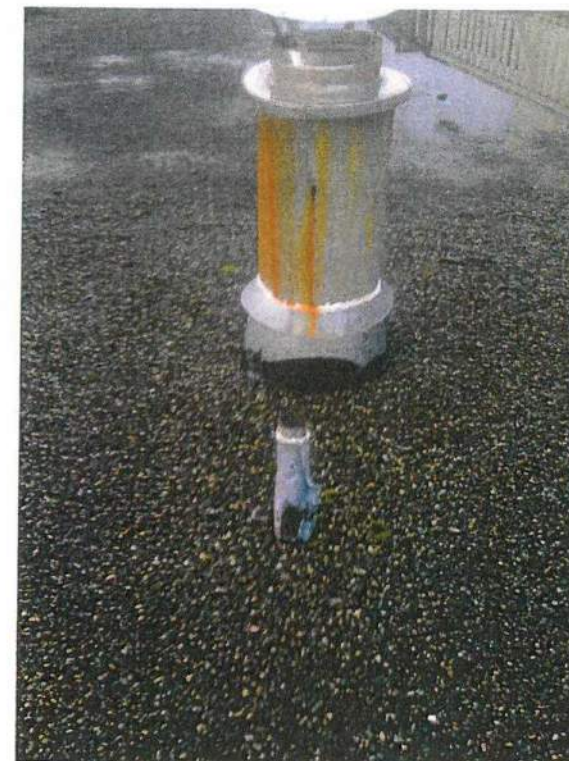
Some roof vents are need of repair or replacement.

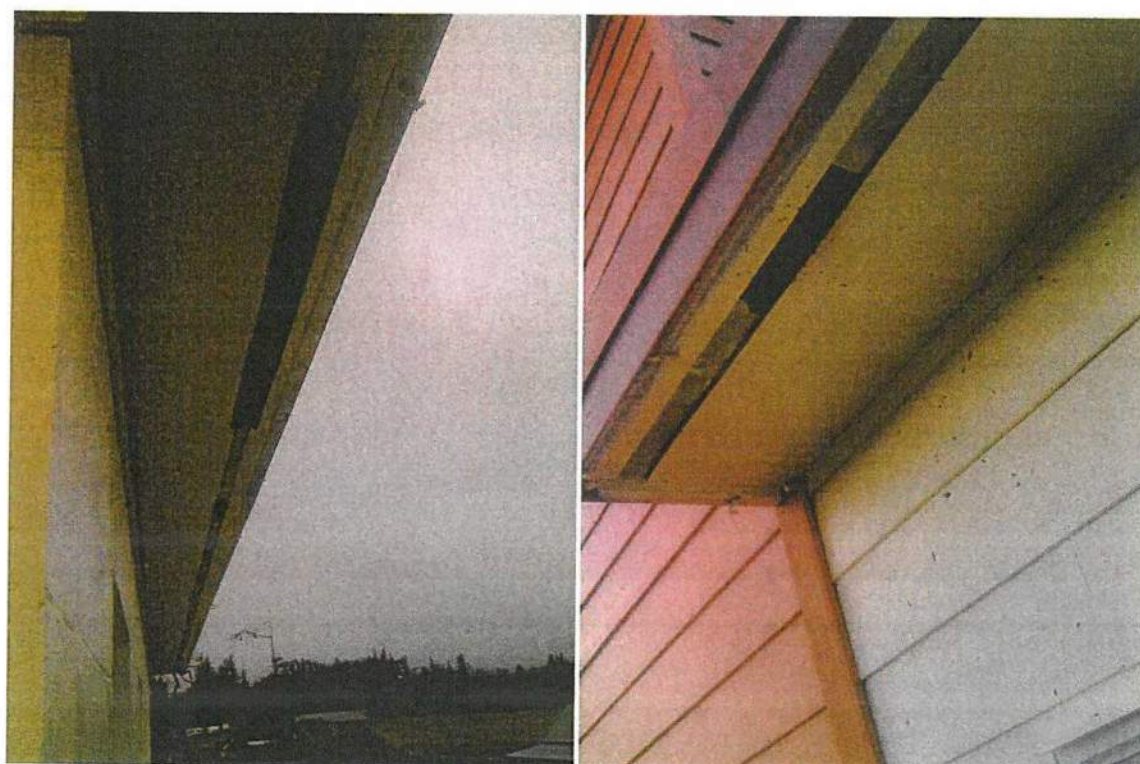
Roof venting, there are many fixes here with different types of methods, due to age, birds are making egress easily for nesting, etc..
