0005-040

Metchosin Firehall
4440 Happy Valley Rd,
Victoria, BC
V9C 3Z3

**Re: Metchosin Firehall Costing Review
Final Report**

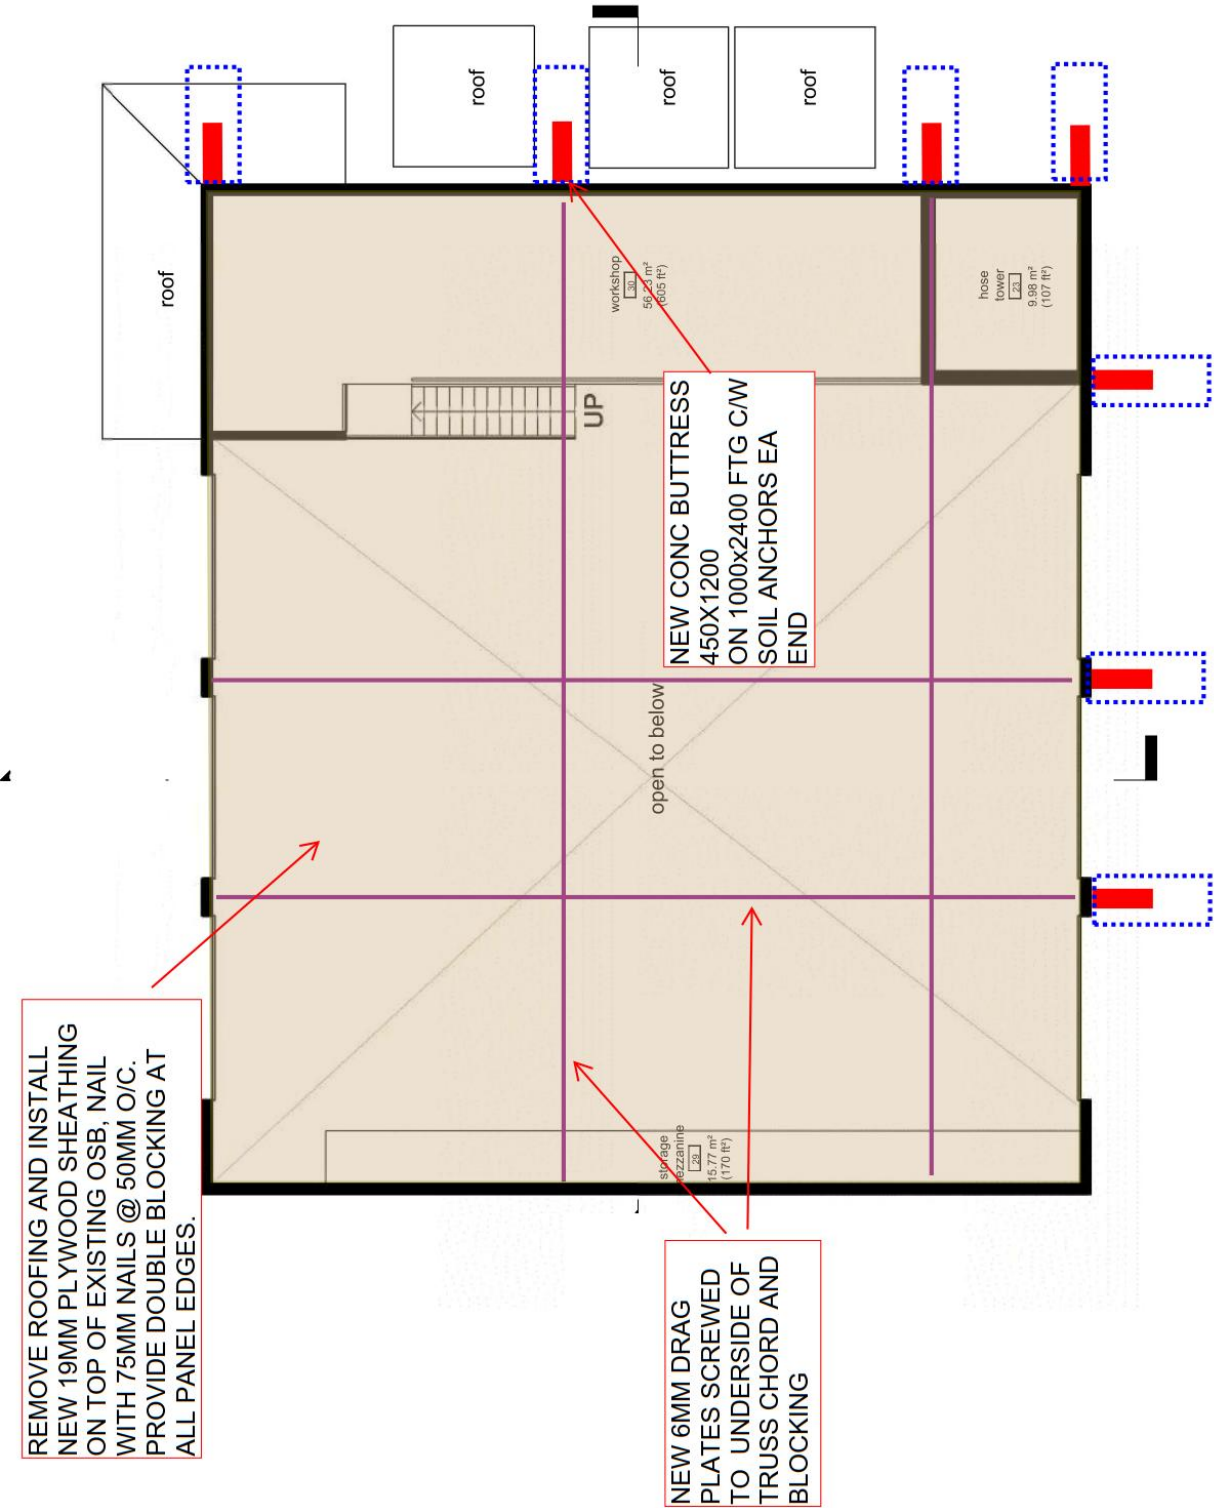
The existing building has two primary weaknesses governing the seismic capacity of the structure: the lack of stiffness in the east-west direction due to the large overhead door openings for trucks, and a low-capacity, poorly connected wood roof diaphragm supporting heavy concrete walls. To address these weaknesses, Herold has developed a schematic design to illustrate the scope of work anticipated to bring the building in compliance with current code seismic requirements.

The proposed seismic upgrade work includes new lateral elements to address the weakness in the east-west direction and to reduce the diaphragm loads in both directions to a level that can be accommodated by wood construction as well as work to upgrade the existing wood diaphragm to meet current demand. The structural scope of work is as follows and as shown on page 4:

- Construction of seven new reinforced concrete buttresses around the exterior of the building. Buttresses to be 450mm wide x 1200mm long x 5200mm tall on new 1000mm wide x 2400mm long x 750mm thick footings. Soil anchors are needed to resist the buttress overturning loads at each end of the footing.
- Remove existing roofing and install new 19mm plywood sheathing over the existing OSB sheathing and install new double wide wood blocking around all panel edges. Blocking can be installed from either the attic space or by locally cutting out strips of the existing OSB sheathing. Add new steel tie plates connecting the roof diaphragm to the new buttress walls and install new roofing.

- Provide new steel strap connection plates between the upgraded roof diaphragm and the existing tilt-up concrete walls.
