Metchosin Firehall Building Assessment

issued: 2025-June-19

1.0 summary

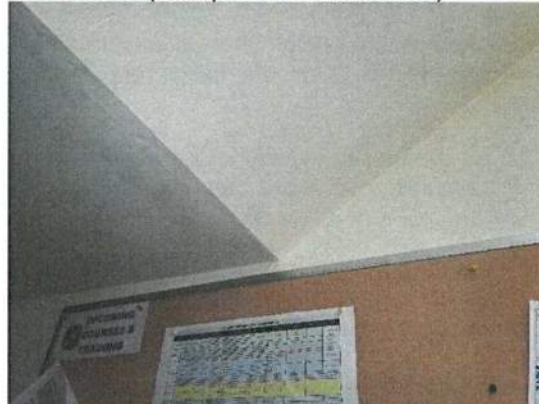
Photo 1: Drywall Compound – Main Floor Stairs to Truck Bay (ND – none detected)

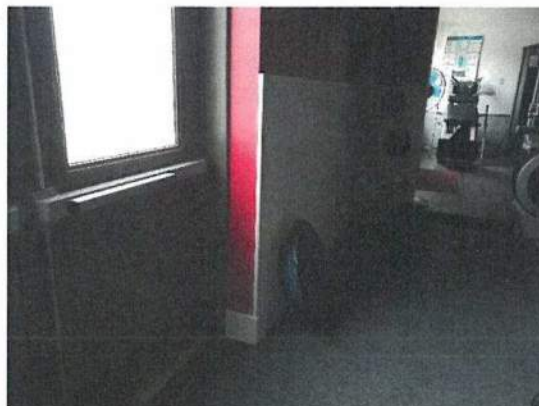
Photo 3: Drywall Compound – Sauna Room (ND)

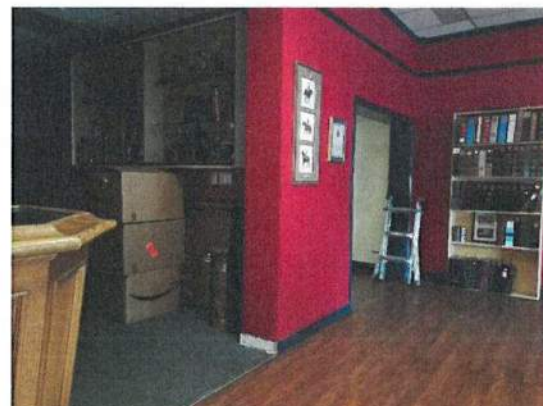
Photo 4: Drywall Compound – Reception Hallway (ND)

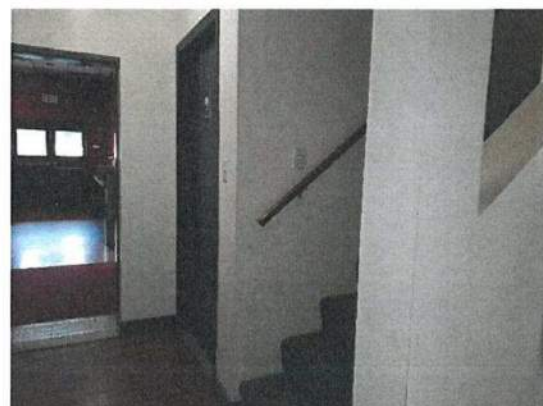
Photo 6: Drywall Compound – Stairs To 2nd (ND)

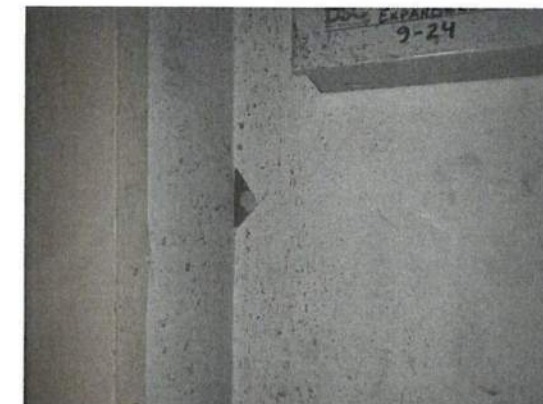
Photo 7: Drywall Compound – Cleaning Closet (ND)

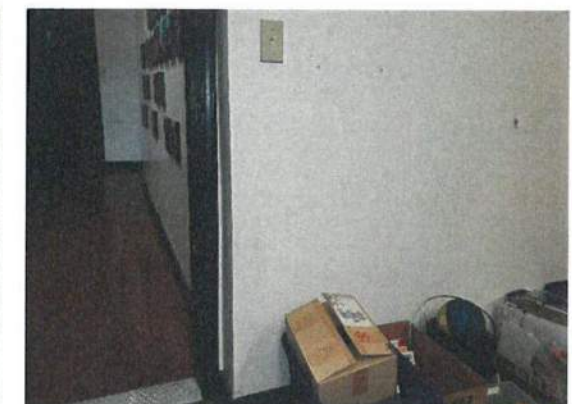
Photo 8: Drywall Compound – Training Room (ND)

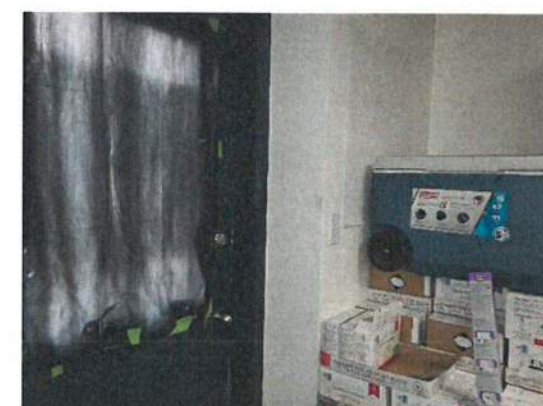
Photo 9: Drywall Compound – Storage/Training Room (ND)

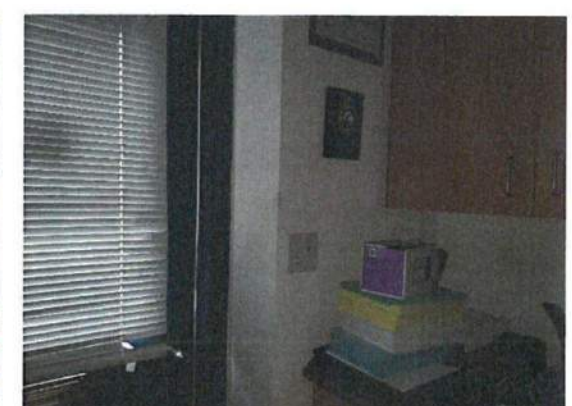
Photo 10: Drywall Compound – Chief Office (ND)

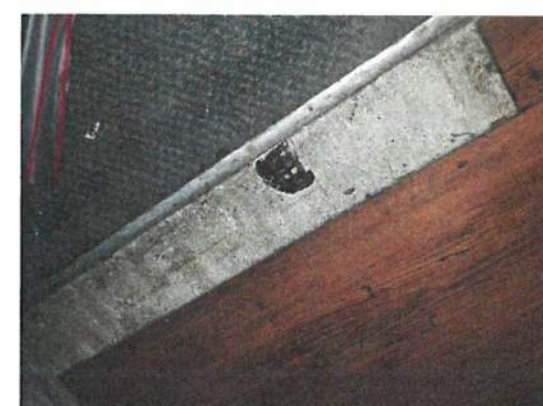
Photo 11: Vinyl Floor Tile – Banquet Hall Below Laminate (ND)

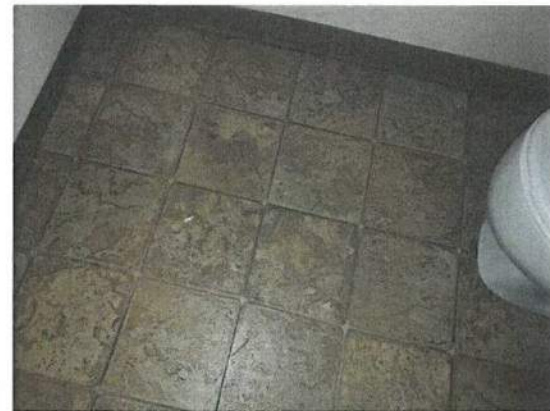
Photo 13: Sheet Vinyl Flooring – Washroom (ND)

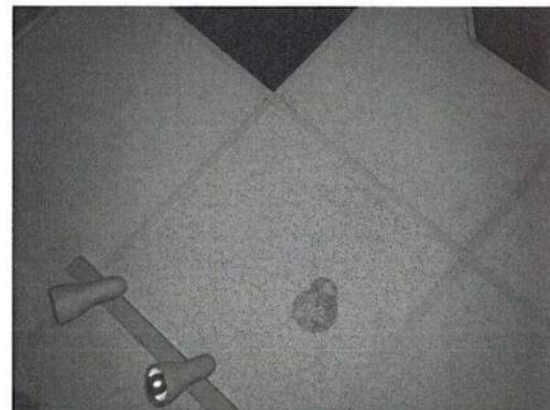
Photo 15: Ceiling Tile – Throughout Main Floor (ND)

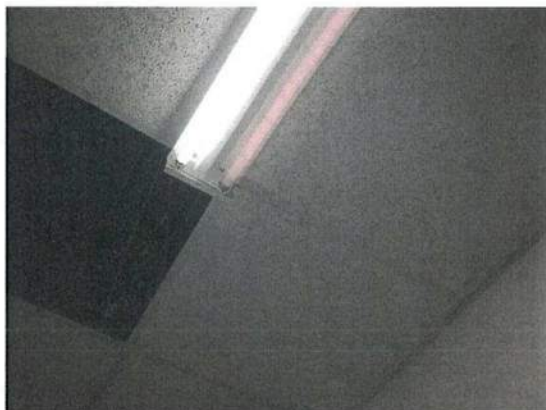
Photo 16: Ceiling Tile – Throughout Main Floor (ND)

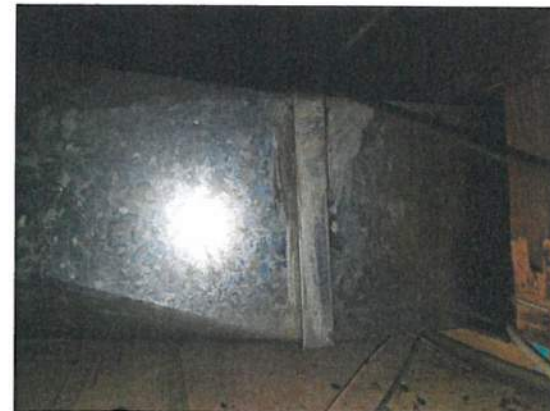
Photo 19: Mastic – HVAC (ND)

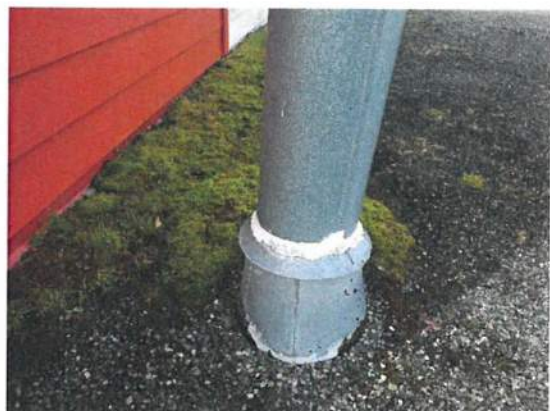
Photo 20: Caulking – Roof on Vent (ND)

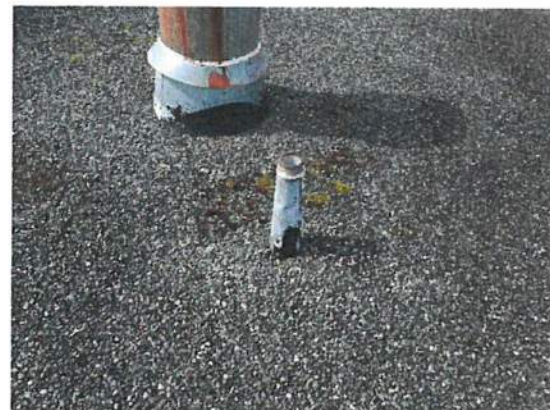
Photo 21: Tar – Roof on Vent (ND)

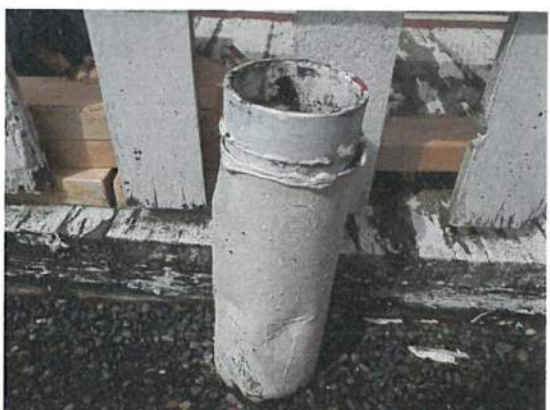
Photo 22: Caulking – Roof on Vent (ND)

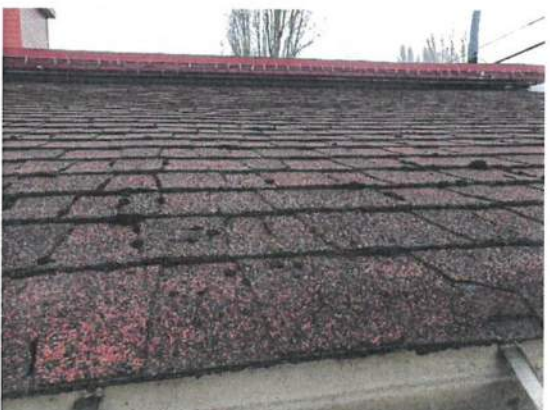
Photo 24: Composite Shingle – Gym Addition (ND)

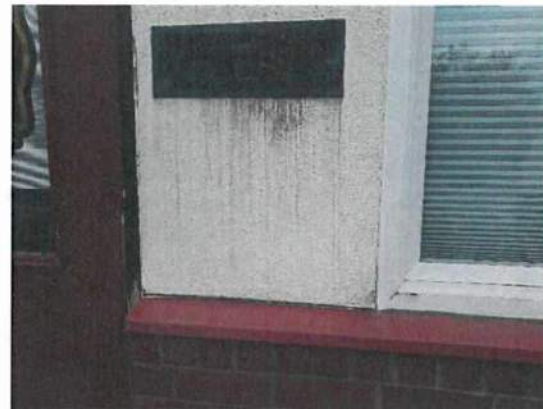
Photo 26: Stucco – Exterior Front
(ND)

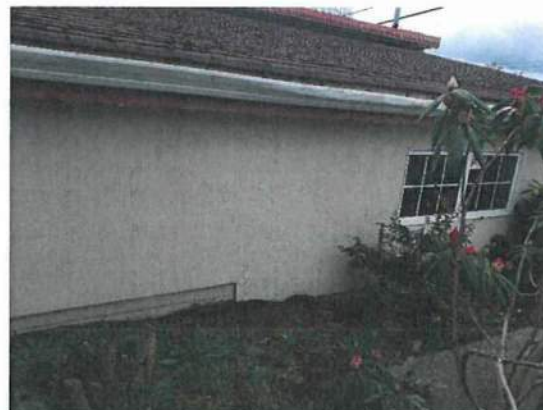
Photo 27: Stucco – Exterior Side
(ND)

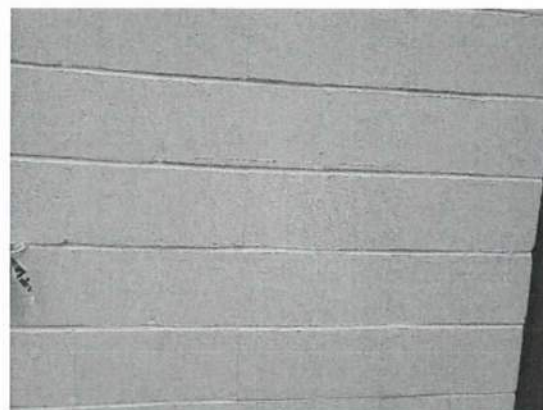
Photo 28: Mortar – Block Mortar
(ND)

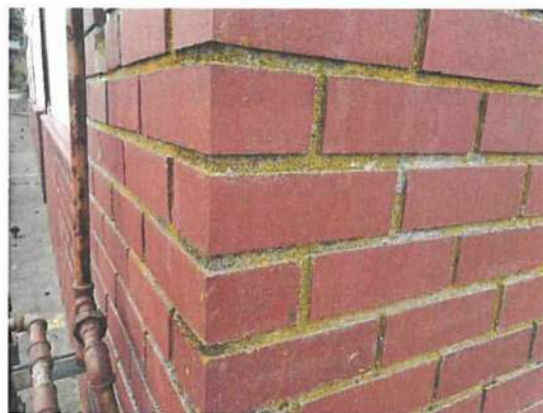
Photo 29: Mortar – Exterior Front
(ND)

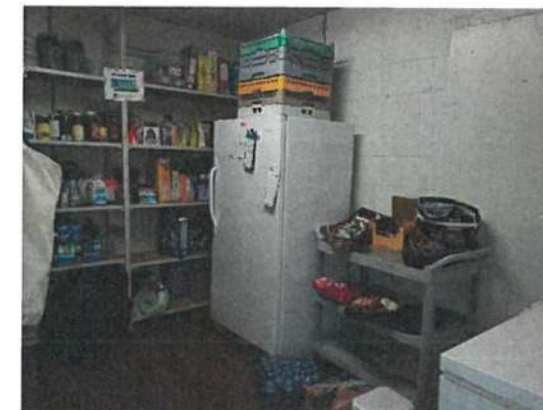
Refrigerator (ODS)

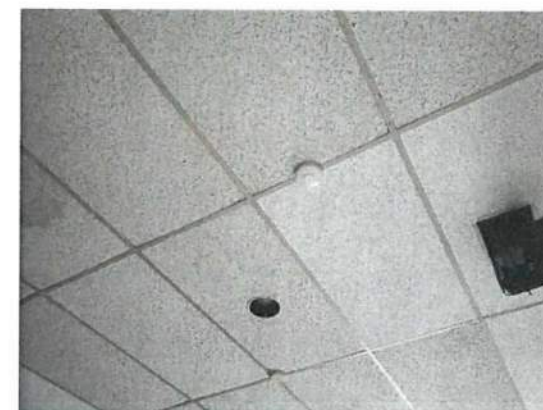
Smoke Detector (Americium)
